Monitoring Data RecordProject Title: U-4026B (Davis Drive) COE Action ID: 200120448Stream Name: Tributary to Burdens Creek (Site 9) DWQ Number: 051972City, County and other Location Information: Durham County, Davis Drive (Sta. 284+50RT.)Date Construction Completed: 12/5/07 Monitoring Year: (3) of 5Ecoregion: _____ 8 digit HUC unit 03030002

Tributary to Burdens Creek

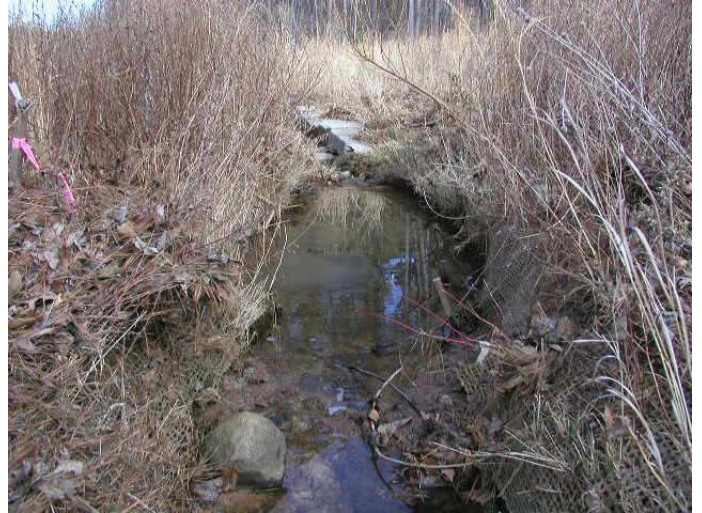
The Tributary to Burdens Creek is stable for Year 3 Winter evaluation, except for two slight headcuts that have formed at Stations 284+50 (Photo Point #1 Downstream) and at Station 285+50. The headcuts have not changed since the summer evaluation and these areas remain stable. NCDOT personnel met onsite on 5/11/09 to discuss possible options for corrective action. It was decided at that time that corrective action was not necessary and NCDOT would continue to monitor the stream relocation. A bankfull event was noted during this monitoring cycle.

Date Inspected 1/15/10	Station Number Sta. 284+50 Photo Point #1 (Downstream)	Station Number Sta. 285+50 Additional photo	Station Number	Station Number	Station Number
Structure Type		Crossvane			
Is water piping through or around structure?		Water is flowing under crossvane			
Head cut or down cut present?	Slight Headcut	Slight Headcut			
Bank or scour erosion present?					
Other problems noted?

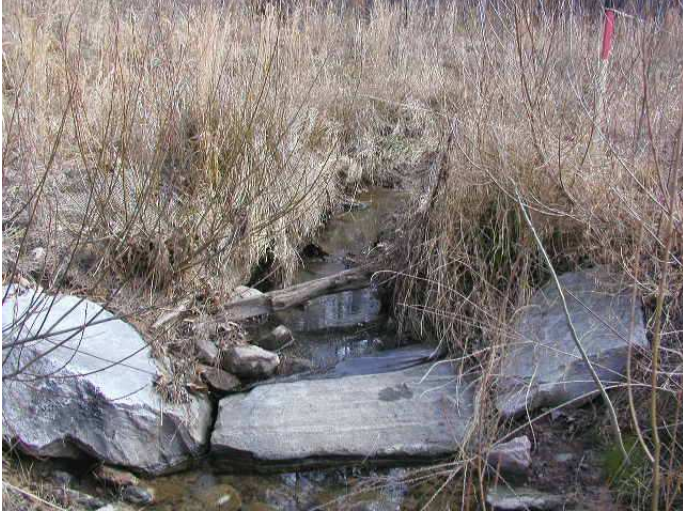
Water is flowing under a crossvane and a slight headcut has formed at Sta. 285+50 which is downstream of Photo Point #3
